Cootamundra Gundagai Regional Council

# **Priority Infrastructure Project: Stormwater Priority Assessment Report**

DRAFT Version 1.1

April 2018

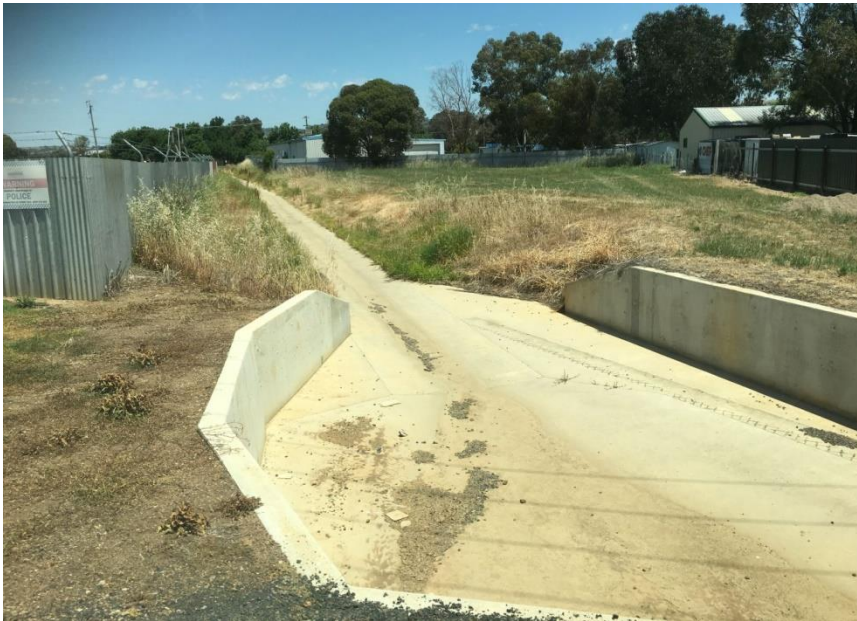
Figure 2 – Improved open drainage upstream of Florance St Cootamundra (C2)

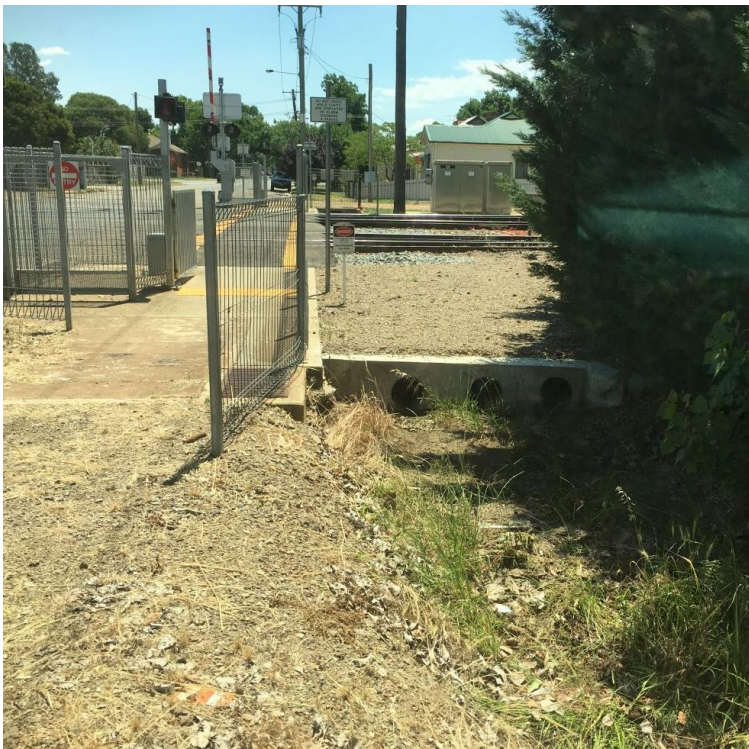
Figure 3 – Pipe Crossing – Pinkerton Street, Cootamundra (C15)

C15	Cootamundra	Railway Culvert	Blockage can obstruct flow	Blockage can obstruct flow	Medium	Inspection program to reduce risk of blockage	Maintenance project	\$0 to \$20,000	3
C16	Cootamundra	Pinkerton Rd	Small pipes under railway with limited capacity cause backup	Inadequate pipe capacity under railway with flat gradients	Medium	Review Pipe Capacity and investigate options for augmentation	Design required by consultant, then construction under contract	\$150,000 to \$500,000	3
C17	Cootamundra	Future Development area west of Rinkin Street	Increased flooding downstream	Impacts of urbanisation can increase runoff	High	Release area master planning	Future Release Area Master Planning	Subject to future Release Area Master Planning	3

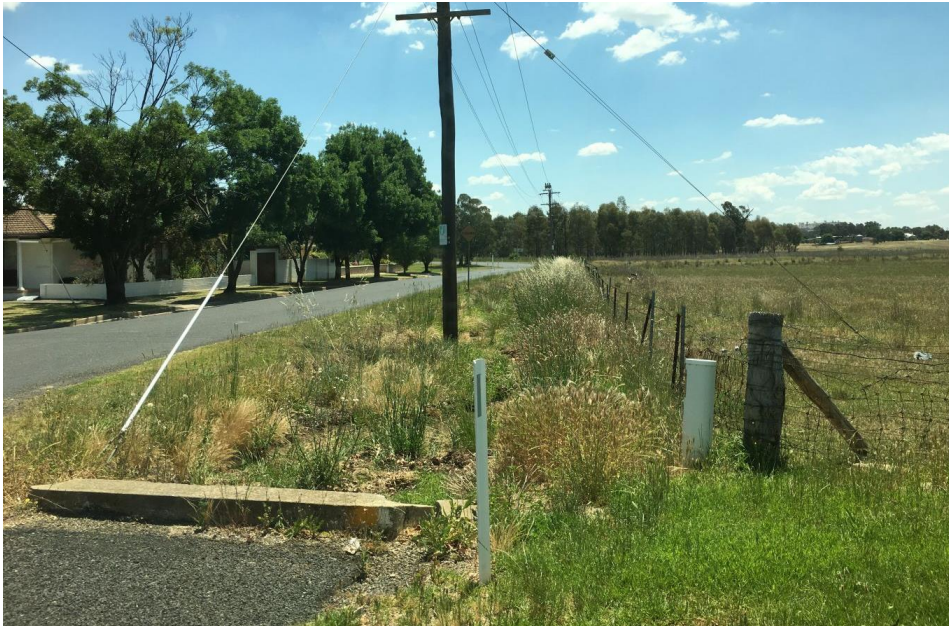
Figure 4 – Open roadside drains – Adams Street north of McGowan Street, Cootamundra (C5)

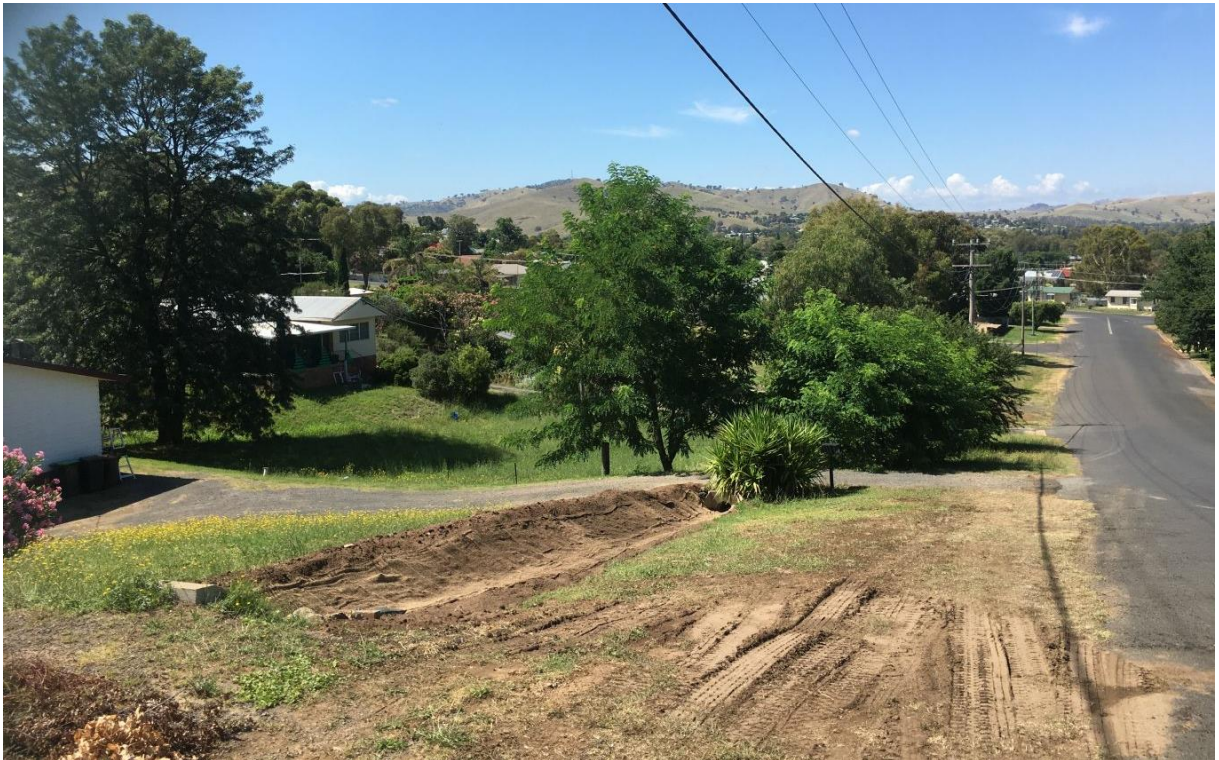
Figure 6 – Inadequate roadside drainage. Tor St Gundagai (G1)

4. That \$150,000 be allocated towards survey, investigation and design of the following projects:
- Tor St, Gundagai. East side road drainage between Nurse Murray St and Jack Moses Avenue

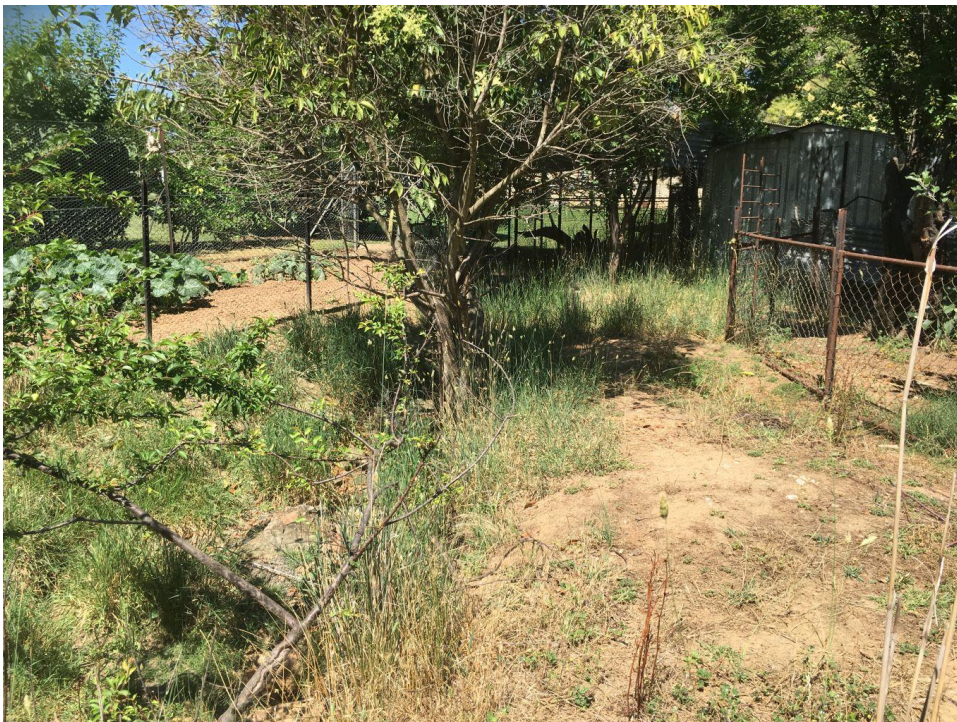
Figure 7 – Stormwater drainage through private property between Tor St and O'Hagan St, Gundagai (G5)

- Sheehan Dr, Gundagai between Nurse Murray St and Jack Moses Avenue- design of roadside drainage including pipes, pits, kerb and gutter
  - Drain on private property between Tor St & O'Hagan St, Gundagai - Design a piped drainage system and overland flow path through private properties

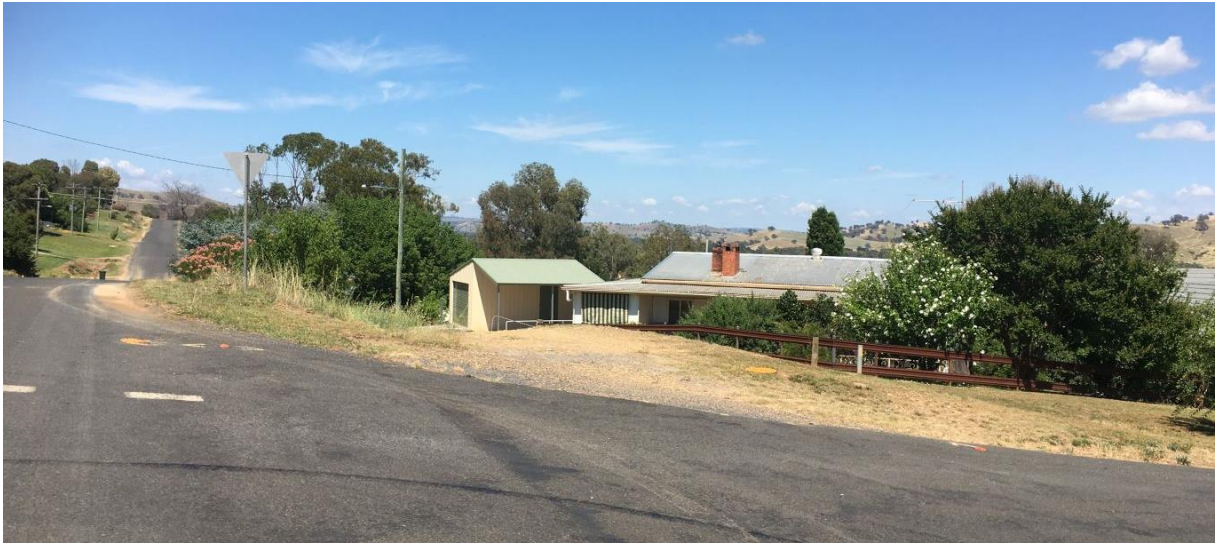
Figure 8 – Runoff into private property. Corner Luke St and Eagle St, South Gundagai (G7)

- Corner of Eagle and Luke St, South Gundagai - Construct kerb and gutter to divert run off down Luke St
  - Continue the construction of concrete “v” drain and grassed channel sides at various locations throughout Cootamundra.

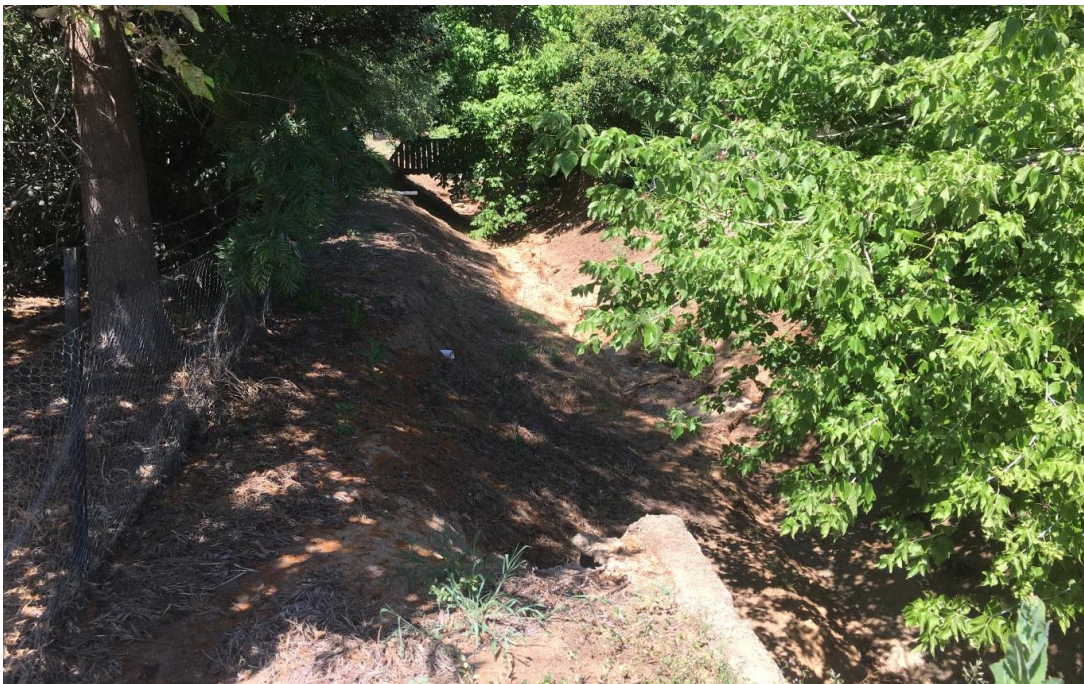
Figure 9 – Open drains through private property. Middle St South Gundagai (G9)

- Open stormwater drain between Middle and South St, South Gundagai (Concrete "v" drain with selective improvements to channel sides and inlet/outlet to structures)

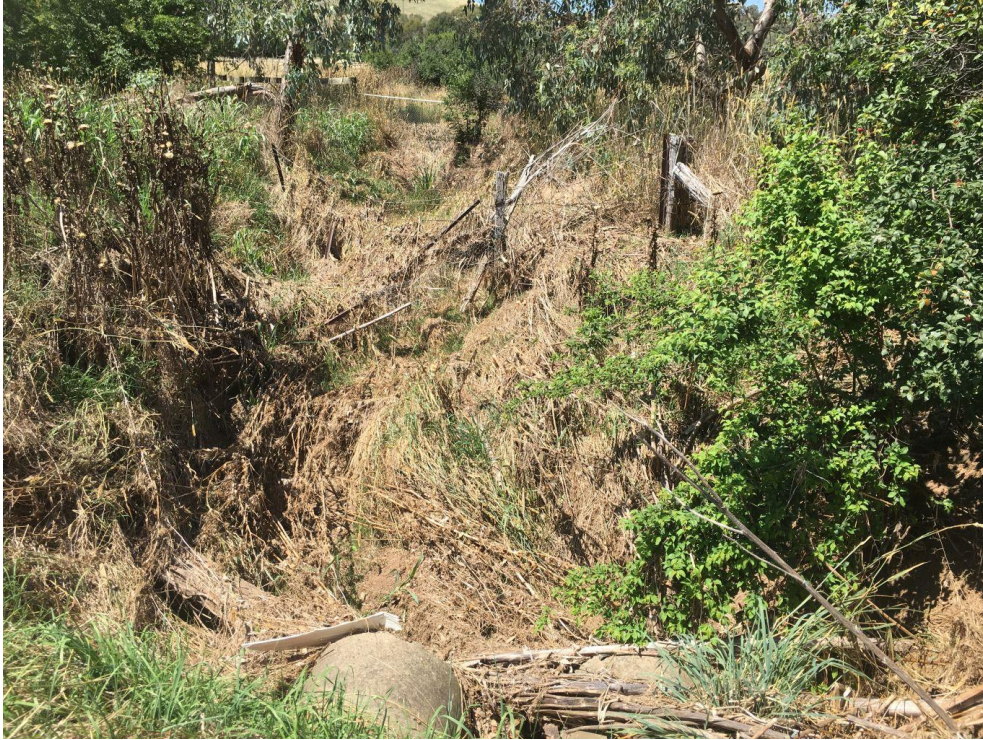
Figure 10 – Open drains at South St and Isaac St South Gundagai (G11)

Ref	Town	Location	What can happen?	Possible cause	Risk rating	Preferred Action	Project Planning Requirements	Cost Range	Recommended Priority
G11	South Gundagai	Isaac St	Flooding of private property and out buildings	Pipe culvert under road too small and heavily vegetated stormwater drains cannot convey stormwater runoff	High	Inspection and cleaning of drain	Maintenance project	\$0 to \$20,000	1
G12	South Gundagai	48 Mount St	Private Property	Runoff from public reserve concentrated in private property	High	Design and construct piped drainage through private property with easement	Design required by consultant, then construction under contract	\$20,000 to \$150,000	1
C1	Cootamundra	Nash's Lane x Muttama Road	Flow of upstream water is obstructed	Vegetation Growth and Siltation	Medium	Vegetation maintenance and desilting	Maintenance project	\$0 to \$20,000	2
C2	Cootamundra	Florance Street near Hume Street	Flow of upstream water is obstructed	Vegetation Growth and Siltation	Medium	Consider installing concrete "V" invert and reshape grassed channel	Minor construction without design	\$20,000 to \$150,000	2

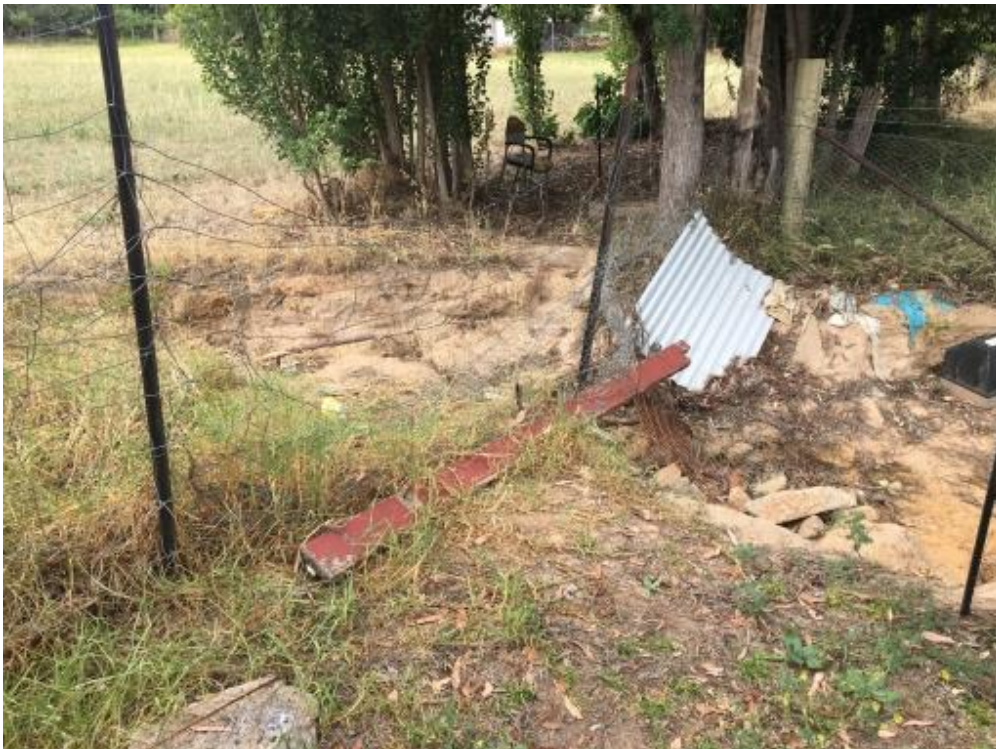
Figure 11 – Open Drain at rear of 48 Mouny Street Gundagai (G12)

- Drain on private property at 48 Mount St South Gundagai - Design a piped drainage system and overland flow path through private property
5. That the remaining \$500,000 be allocated towards construction of the projects listed in priority order in Recommendation 4, which are subject to design work and costing. The expected funding shortfall is to be considered in conjunction with competing priorities in future budgets.

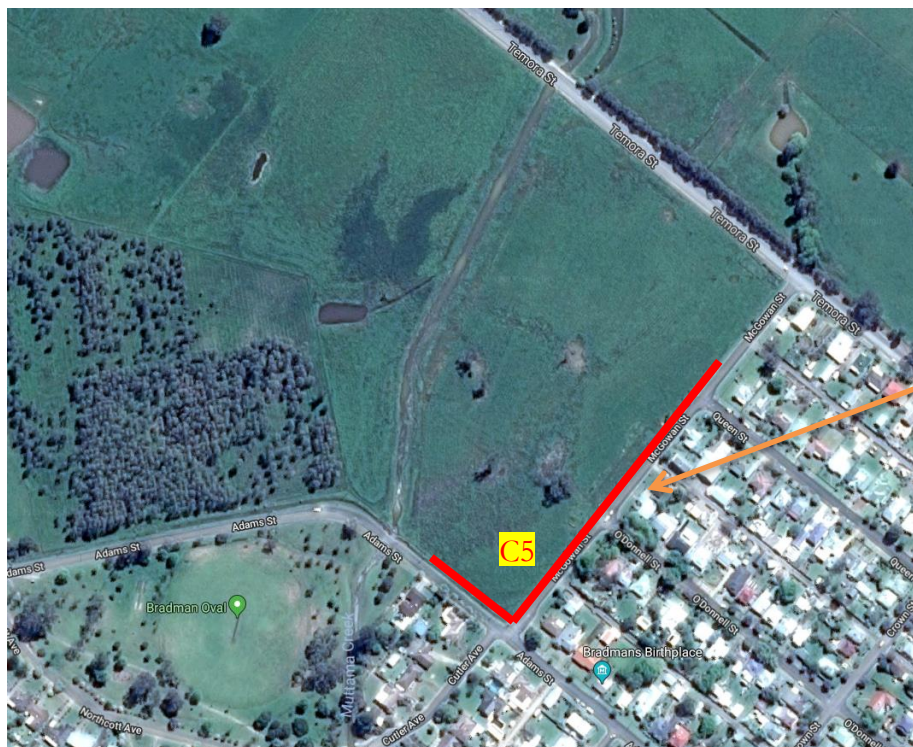
Figure 12 – McGowan Street and Adams St Cootamundra – Separation of creek flows from urban runoff (C5)

Consider installing small levee or grassed earth bank along fence line to separate mainstream flood waters from local water

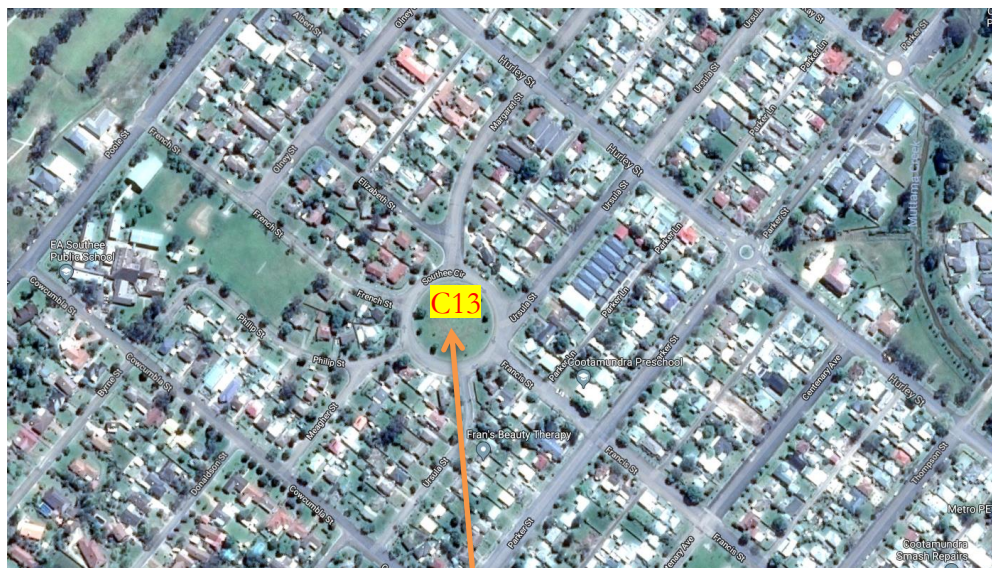
Figure 13 – Southee Circuit subcatchment – Investigate piped drainage and overland flow path (C13)

Investigate pipe and inlet capacity - CCTV inspection recommended. Analyse stormwater capacity and overland flow paths. Design required for improvements. Consider construction of improvements once scope of works and cost is known

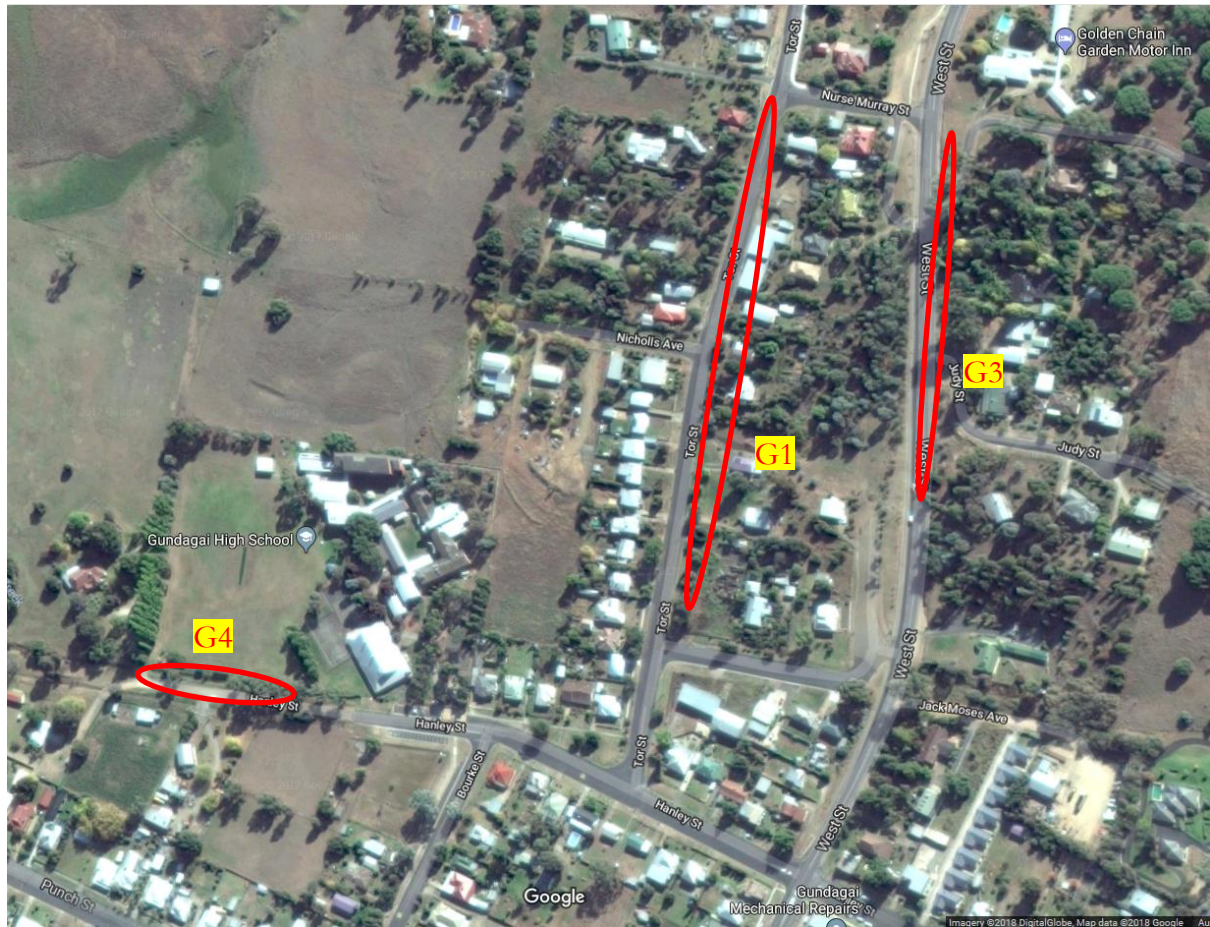
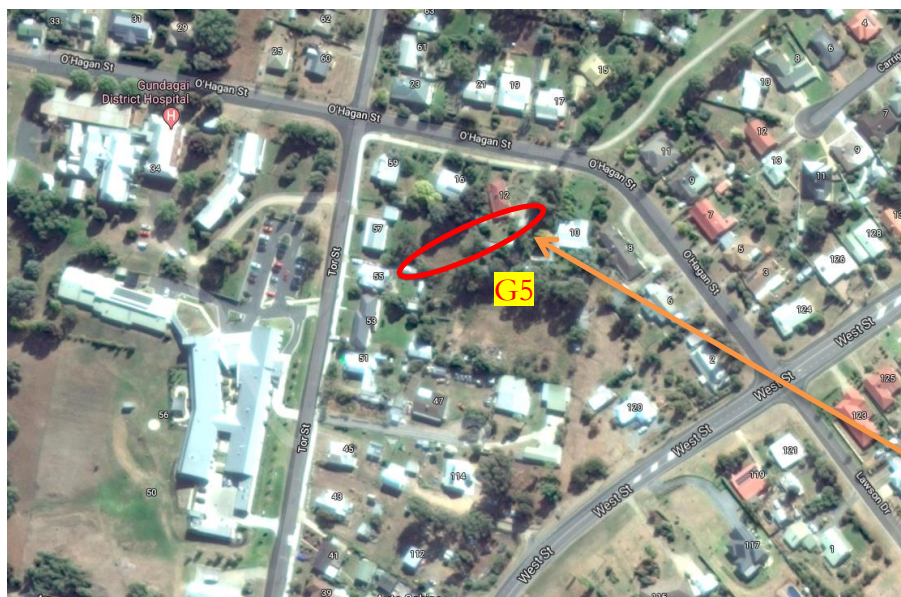
Figure 14 – Stormwater Priorities in Gundagai – Tor St, Sheehan Drive (G1, G2, G3, G4)

Consider the design and construction of improvements to roadside drainage

Consider the design and construction of pipe drainage and overland flow path through private property

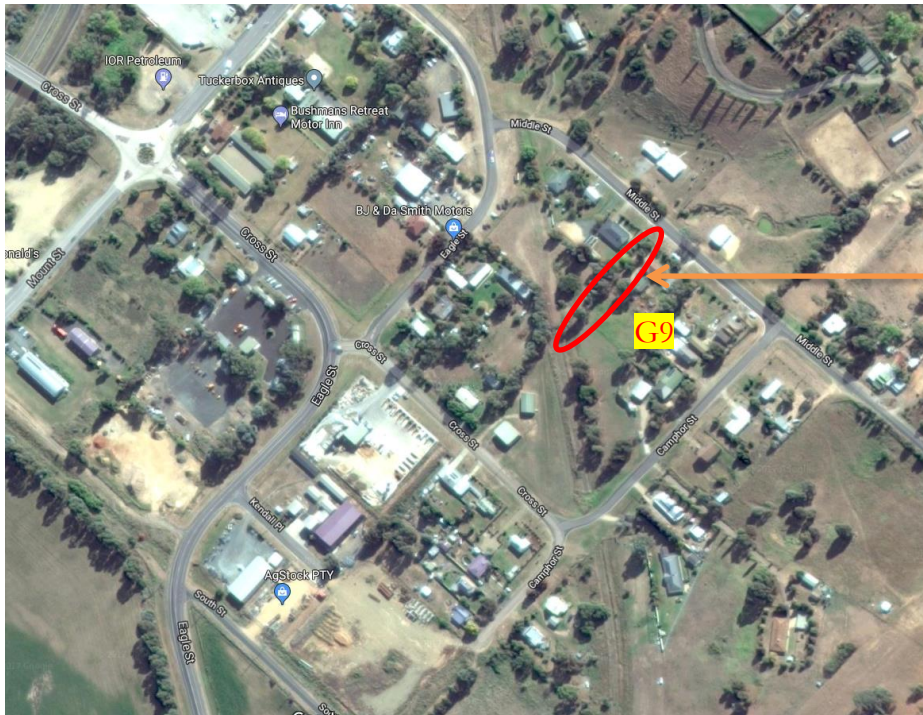
Figure 15 – Stormwater Priorities in South Gundagai (G9, G10, G11)

Consider the design and construction of a concrete “v” drain with selective improvements to channel sides
