**COOTAMUNDRA -  
GUNDAGAI REGIONAL  
COUNCIL**

**Gundagai Sewage Treatment Plant (STP)**

**Treat Effluent Quality Monitoring Report**

**October 2020**

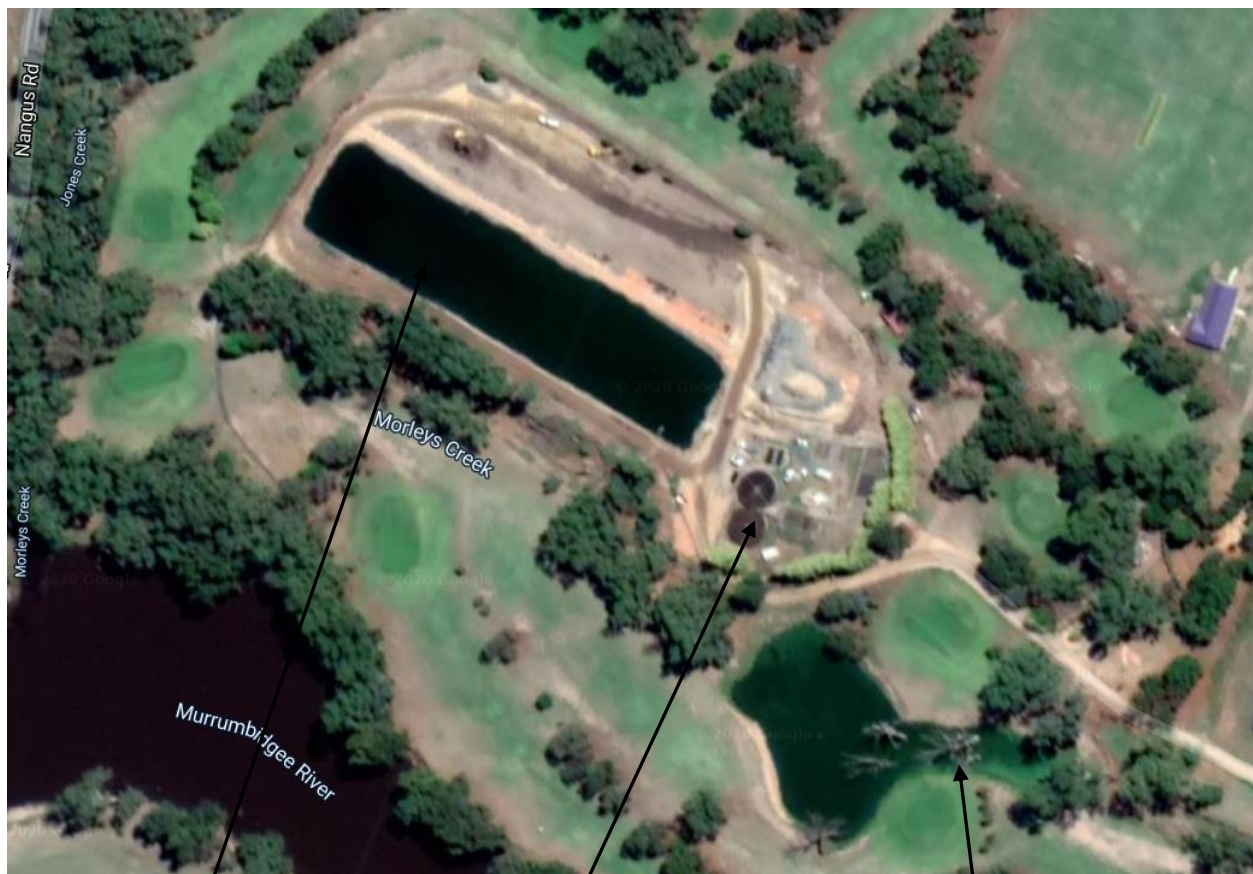
Figure 1- Layout of Gundagai Sewage Treatment Plant

The existing treatment plant consist inlet works, Imhoff tank and trickling filters, humus tank, maturation pond and sludge digester. Digested sludge is discharged into drying beds and disposed at landfill sites. Treated effluent is used to irrigate parks, sporting fields and golf course.

Maturation Pond

Treatment Plant

Golf Course  
Irrigation Pond

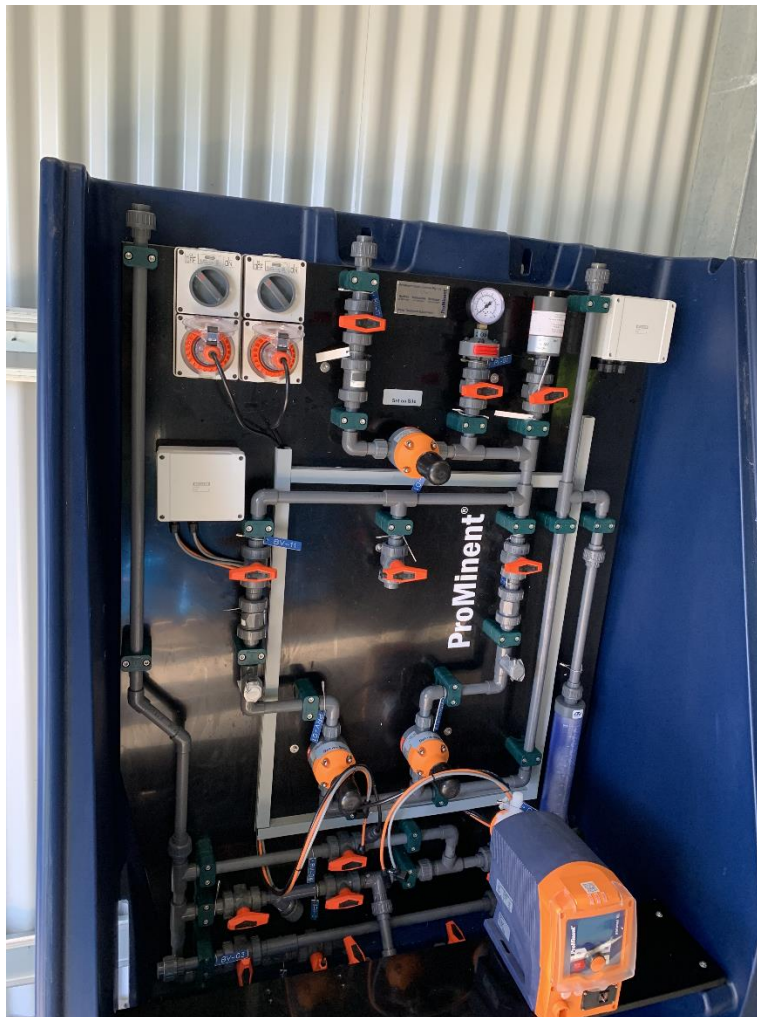
A skid Chlorinator using 12.5% hypochlorite solution was installed, tested and commissioned on 28 August 2020. Subsequent to this the coliform count in the irrigation point has dropped significantly representing an LRV of 3 and above achieved by the disinfection process. Further details can be found in the water quality report in Section 3 of this report.
